Kent Single Sided Flat Kerb

KENT SINGLE SIDED FLAT KERB-KSSFK-290/100

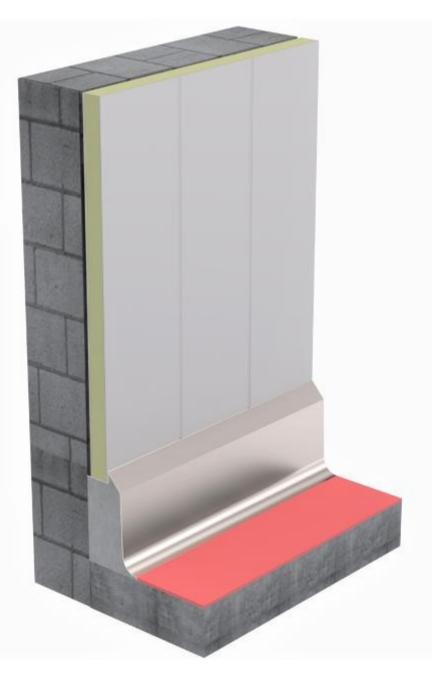
The Kent Single Sided Flat Kerb is designed for areas to provide surface protection to the lower part of walls to resist impact damage from trolleys, mobile bin units and pallet trucks. The overall design of the kerbing ensures they are easily cleaned with smooth joints to both walls and floors providing virtually ledge and crevice free surfaces. The single sided flat kerb can easily butt against existing walls for easy installation, typically used on the inside of factory perimeter walls

- 2mm or 3mm thick steel
- 320 grit satin finish
- Spaced fixing plates for bolting to ground
- Grade 304 stainless steel as standard, Grade 316 on Request.
- No dirt traps
- Easy to install system

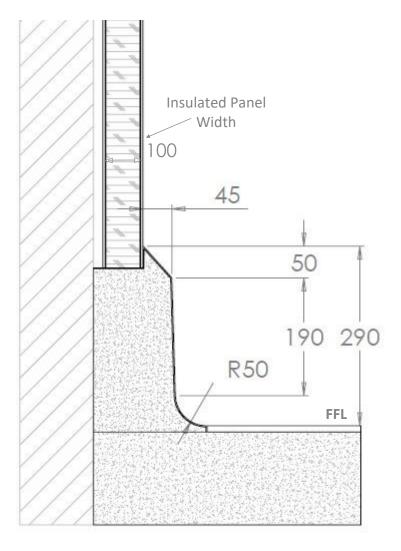
KENT SINGLE SIDED FLAT KERB-KSSFK-290/100

Product Code	Height	Insulated Panel Width
Kent Single Sided Flat Kerb KSSFK-290/100	290mm	100mm
Kent Single Sided Flat Kerb KSSFK-290/150	290mm	150mm
