# Kent Flat Ladder Gully Grates

## KENT FLAT LADDER GRATING—KFLG-560/300

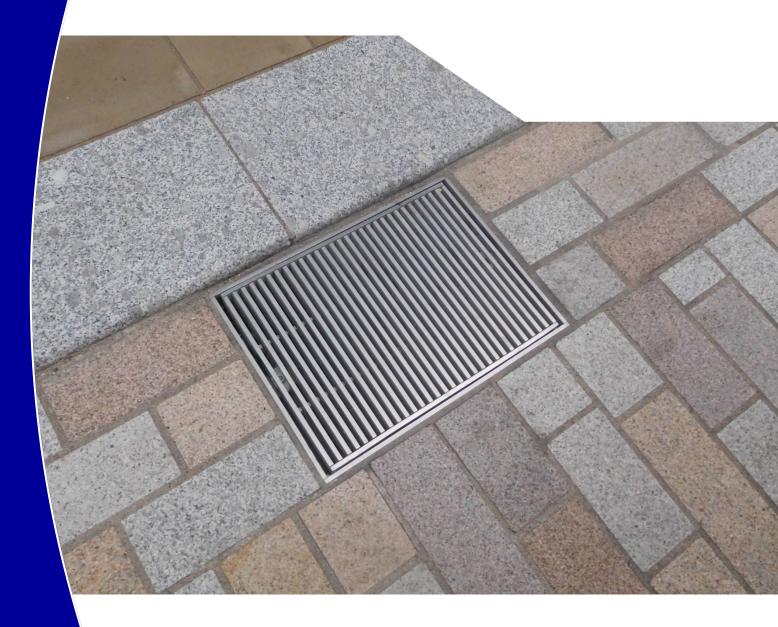
The Kent Dished Ladder Gully Grates are external heavy duty gully covers.

They are curved to suit a dished channel (any radius possible).

They come in Grade 316L Stainless Steel as standard (for roads that are de-iced with salt) and also available in grade 304L. They are supplied with a discreet hinge and hidden lockdown point as standard.

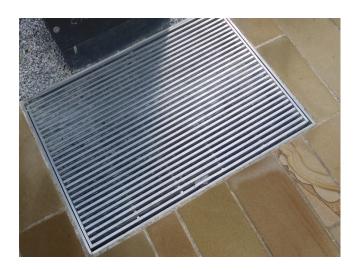
Hidden Locks

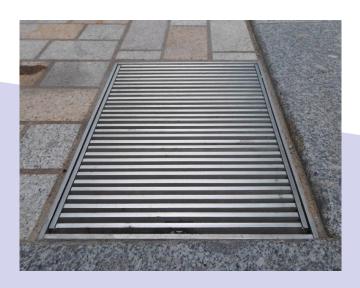
Discreet Hinges

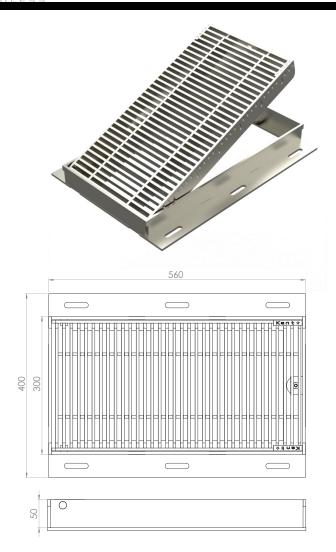
44 Ton Truck Loading

FACTA B Loading as standard or EN124 B125 Loading on request—each to take a slow moving pneumatic tyre of a HGV—44 Ton vehicle with 11 Ton Axle Load and 5.25 ton wheel load.

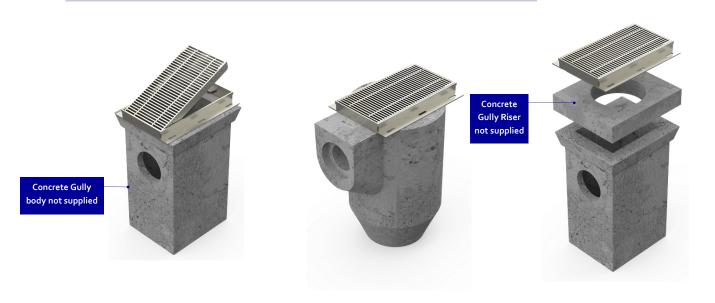
Product Code	Length	Width	Depth
KFLG-560/300 (L)	56omm	300mm	50mm
560mm x 300mm x 50mn
