Kent
STAINLESS

07/2023

Bright Peened

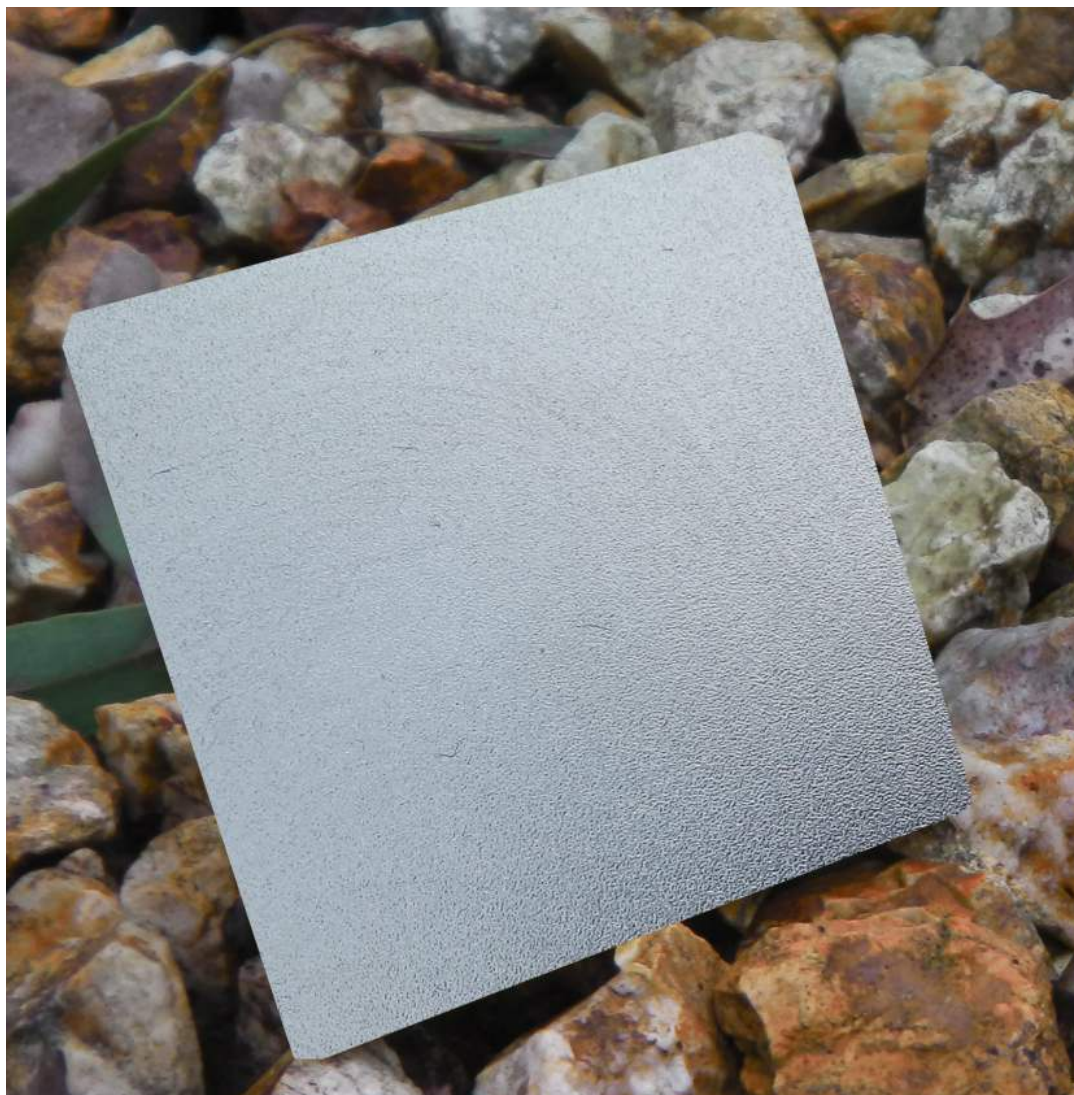
Bright Peened finish, is a uniform, non-directional finish, similar to Shot Peened, except it is slightly brighter. The Shot Peening process is repeated but an electropolishing stage is added afterwards.

Kent Internal reference is 'KF7' and appended with 'Bead Blasted – Electropolished'. After blasting the product (when size allows) is submerged in an electropolishing tank to brighten the surface, reduce the Ra value and enhance the longevity of the stainless in an urban environment.

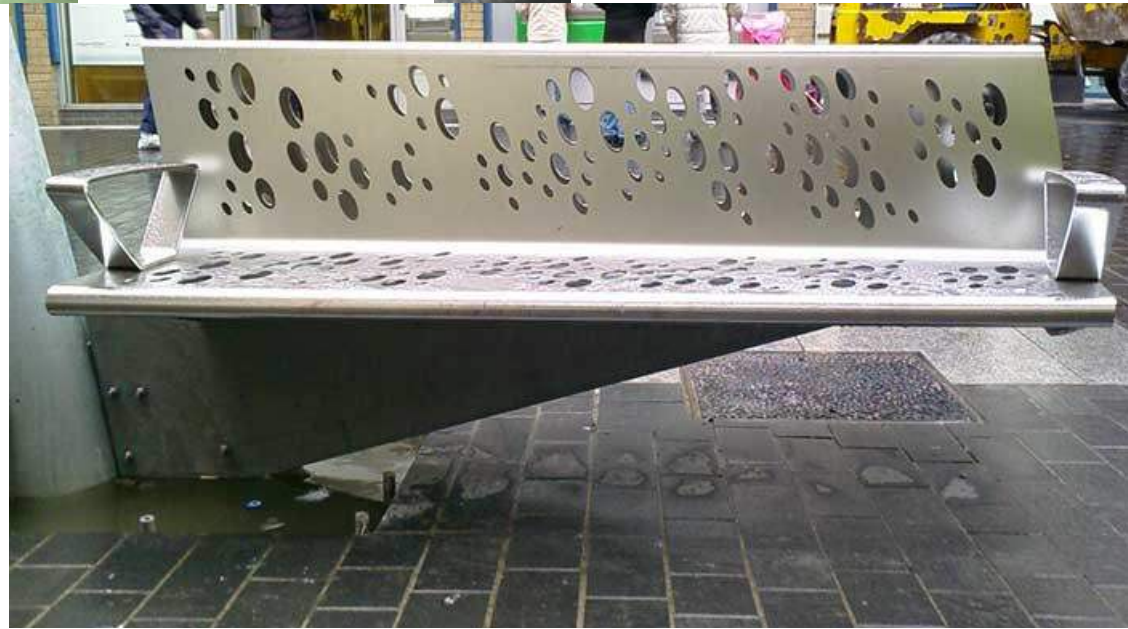
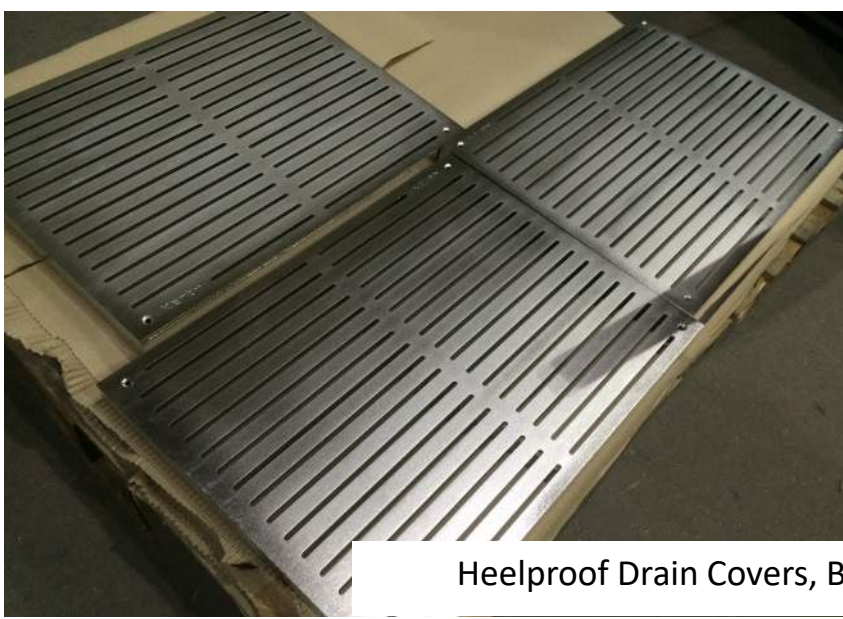
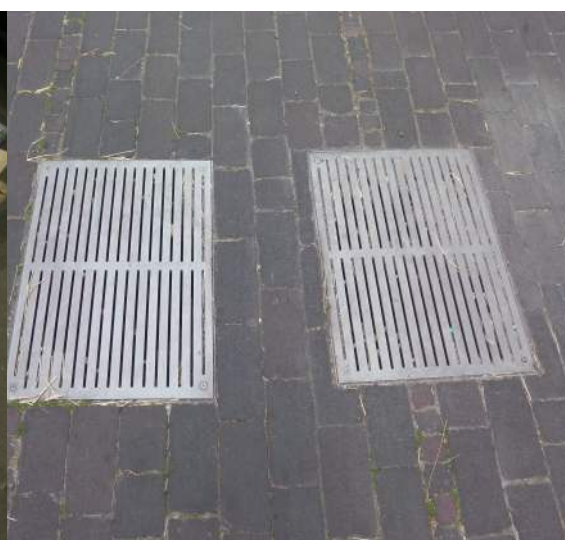
Heelproof Drain Covers, Bermondsey Square, London, UK

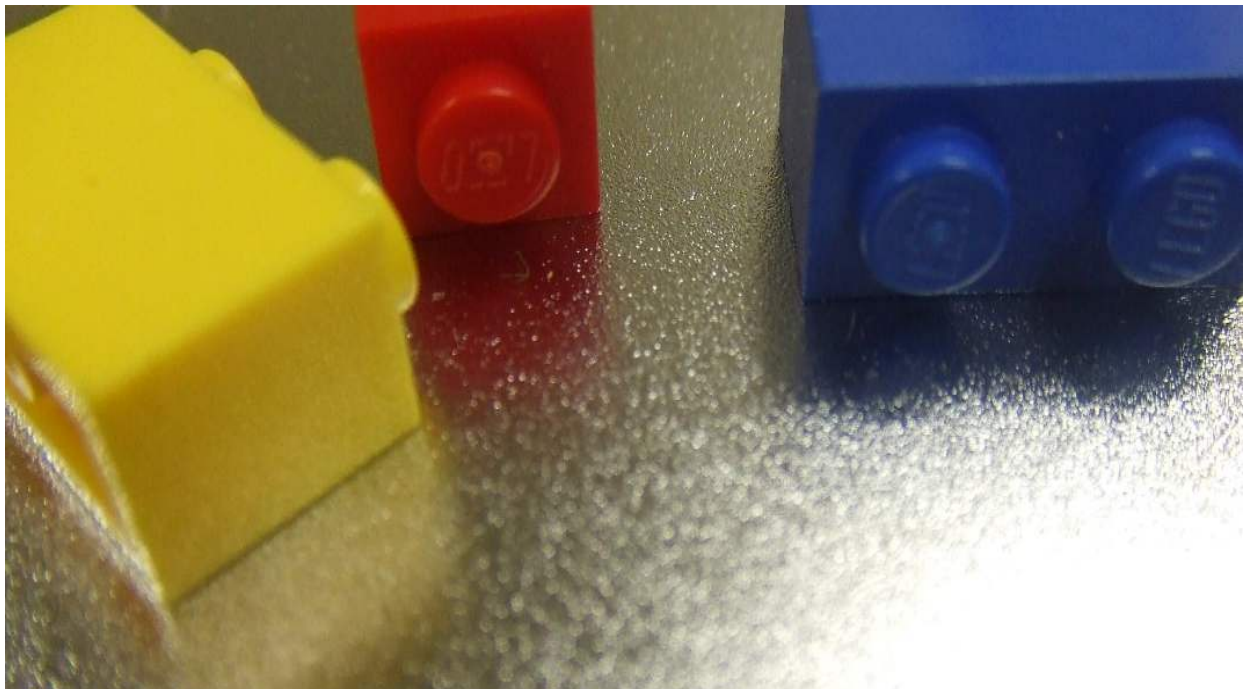
Mottled finish—Some reflection
